3 Bedroom House

# Snagging Details

Description: Snagging Survey

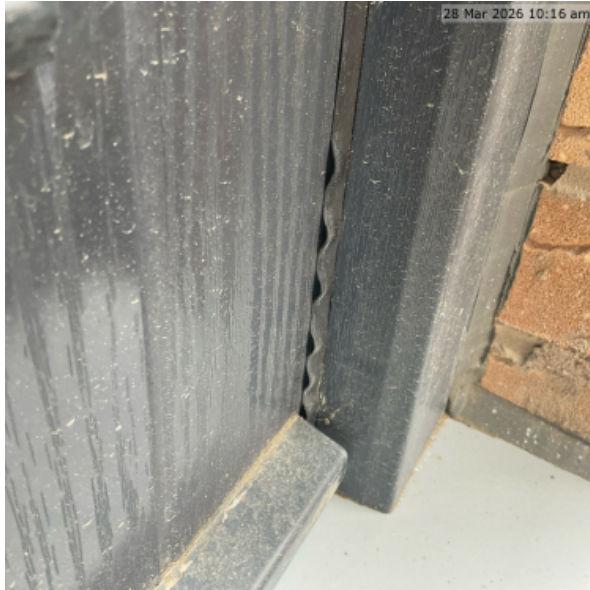
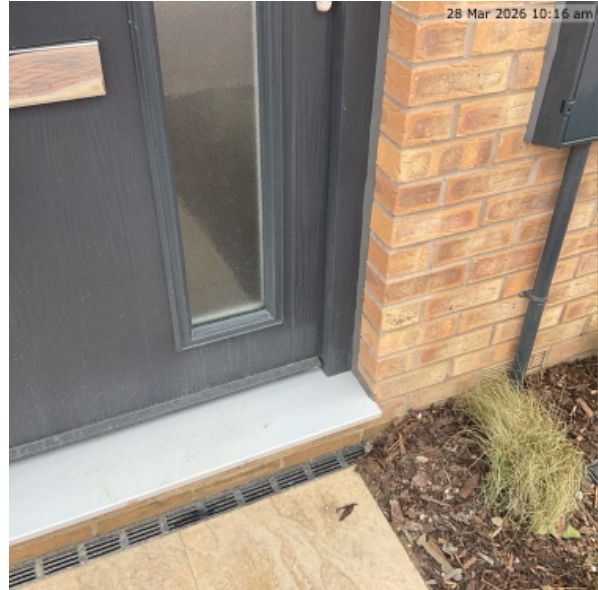
Issue 1

Description: Rippled Door Gasket

The door gasket has been observed to be rippled and uneven along sections of the seal. The gasket does not sit consistently within its channel.

Approved Document C (Resistance to moisture) requires openings to prevent air and moisture ingress.

NHBC 6.7 requires seals to be correctly installed and continuous.

The distortion may affect the effectiveness of the seal and allow air leakage. This does not reflect the expected standard of installation.

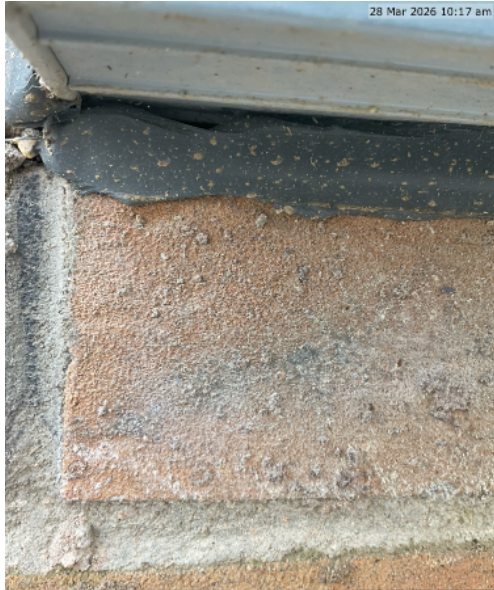
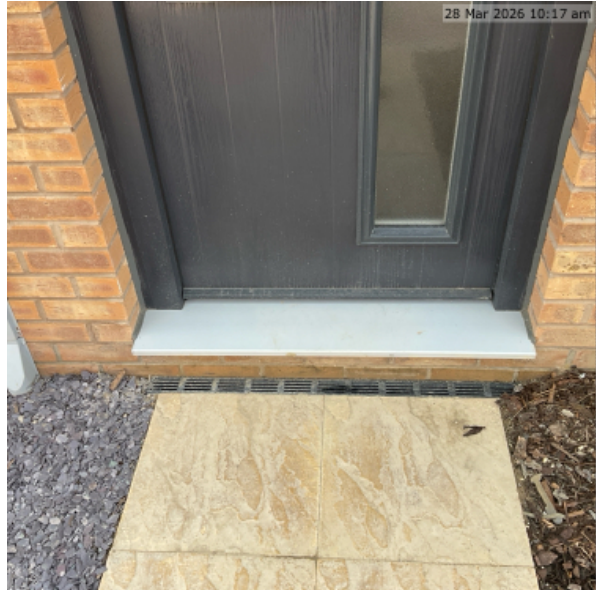
Issue 2

Description: Gaps in Sealant Beneath Door Sill

Sealant beneath the door threshold is incomplete with visible gaps.

Approved Document C requires protection against moisture ingress.  
NHBC 6.7 requires continuous sealing.

Gaps may allow water and air ingress and indicate incomplete finishing.

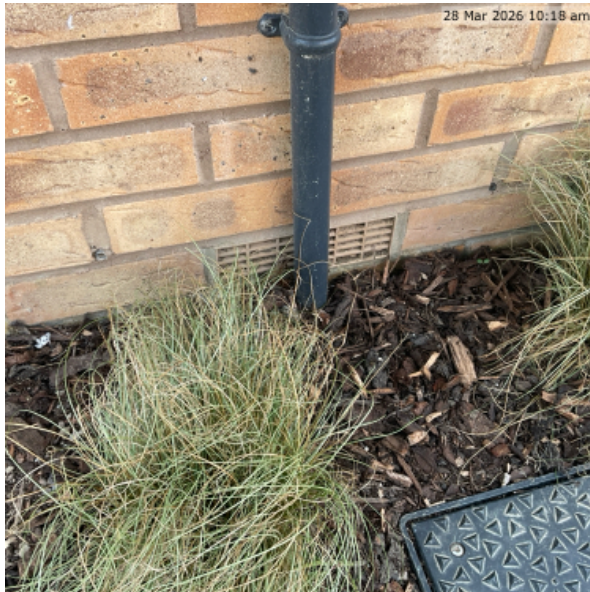
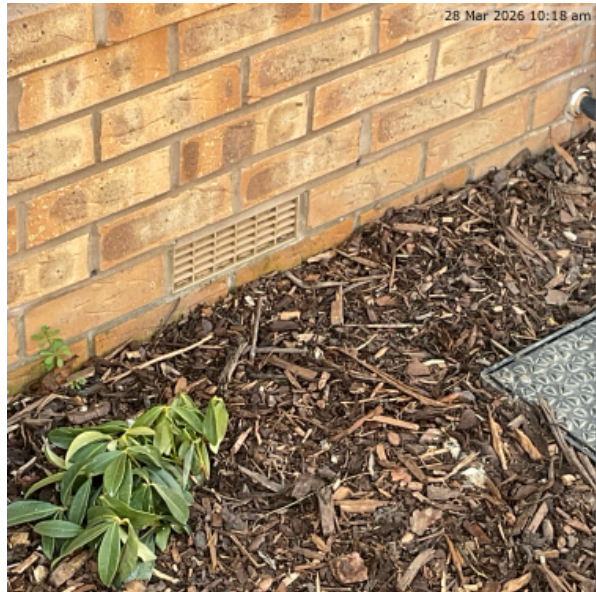
Issue 3

Description: Air Bricks Below 75mm Above Ground Level

Air bricks are positioned less than 75mm above ground level.

Approved Document C and NHBC 6.1 require minimum 75mm clearance.

Reduced clearance increases risk of blockage and moisture ingress.

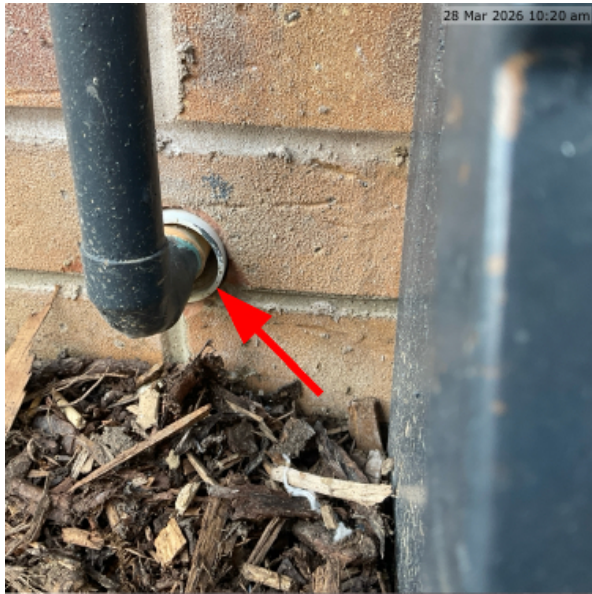
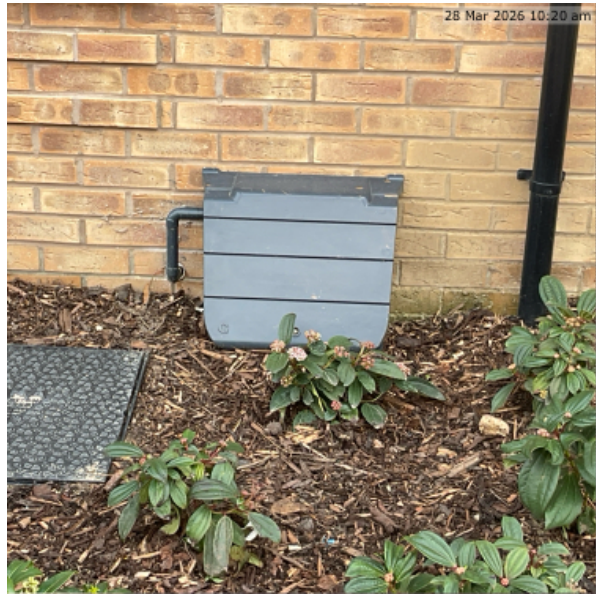
Issue 4

Description: Unsealed Pipe Penetration

Observation  
Pipework penetration through the wall is unsealed.

Relevant Guidelines  
Approved Document C requires sealed penetrations.  
NHBC 6.1 requires proper sealing.

Assessment  
Allows air and moisture ingress. Poor workmanship.

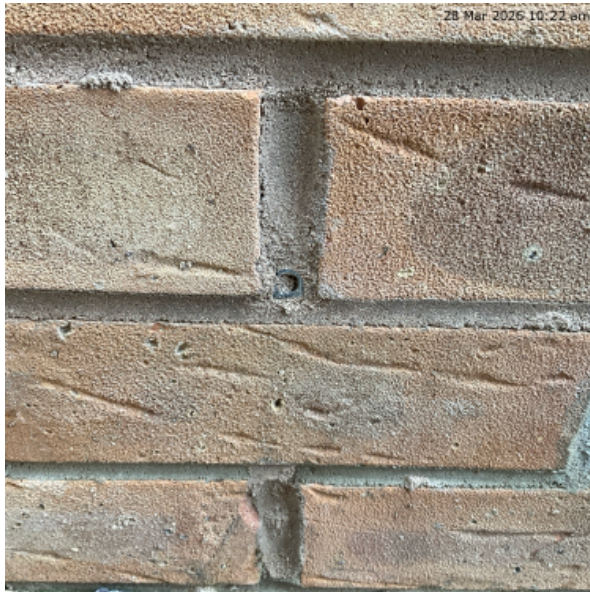
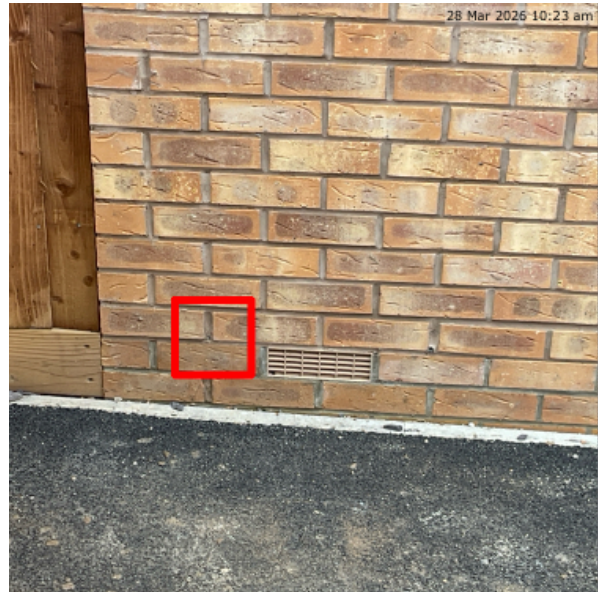
Issue 5

Description: Blocked Weep Vent

A weep vent has been obstructed with mortar/debris.

Approved Document C requires cavity drainage.

NHBC 6.1 requires weep vents to remain clear.

The blockage prevents moisture from escaping the cavity, increasing risk of damp. This does not meet expected standards.

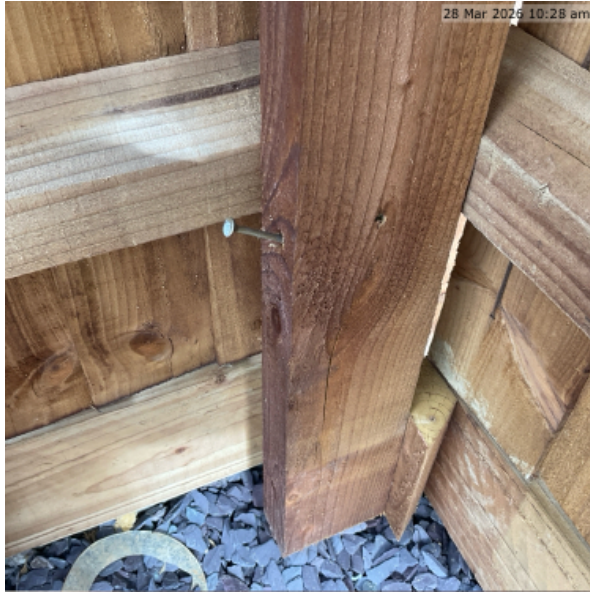
Issue 6

Description: Protruding Fixing to Fence Post

A fixing has been left protruding from the fence post.

Approved Document A requires safe installation.

NHBC 10.2 requires safe and properly finished external works.

The protrusion presents a minor injury risk and indicates poor finishing.

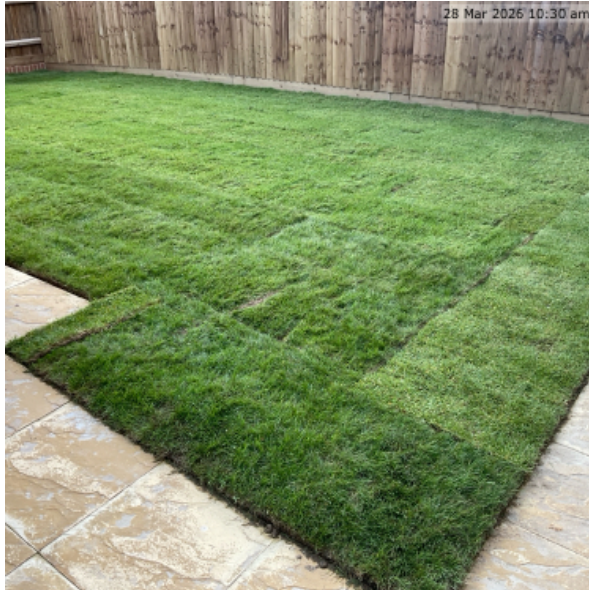
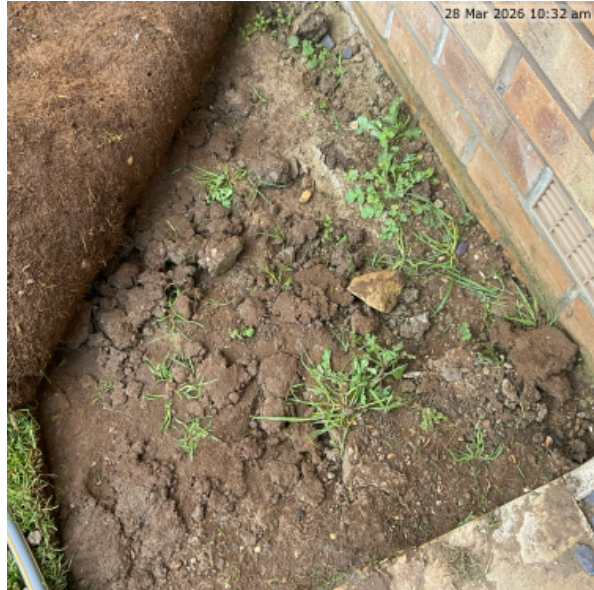
## Issue 7

Description: Turf Installation and Ground Preparation

The ground beneath the recently laid turf has been observed to contain areas of compacted soil, visible clay and stones, with limited evidence of a well-prepared topsoil layer. The surface appears uneven in places and the turf has been laid directly over this material.

NHBC Standards Chapter 10.2 (External works) states that topsoil should be of suitable quality and adequately prepared to support vegetation growth, including being free from excessive debris and properly cultivated prior to turfing.

The observed ground conditions suggest that preparation of the subsoil and topsoil may be limited. Adequate preparation is important to allow turf to establish strong root growth and to ensure effective drainage. Where soils are compacted or clay-heavy, water may not drain effectively and turf may struggle to establish, potentially leading to areas of die-back or poor growth.

This is not confirmed as a defect at this stage; however, the client is advised to monitor the condition of the turf over the coming weeks. Should areas of turf fail to establish or deteriorate, the underlying ground preparation is likely to be a contributing factor and should be raised with the developer.

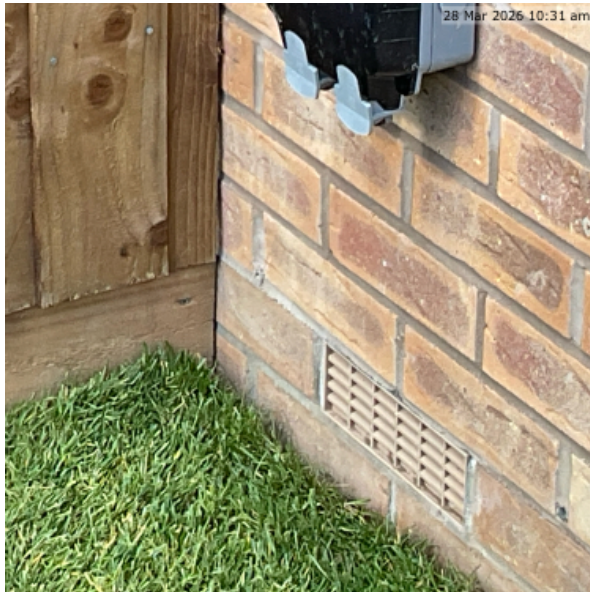
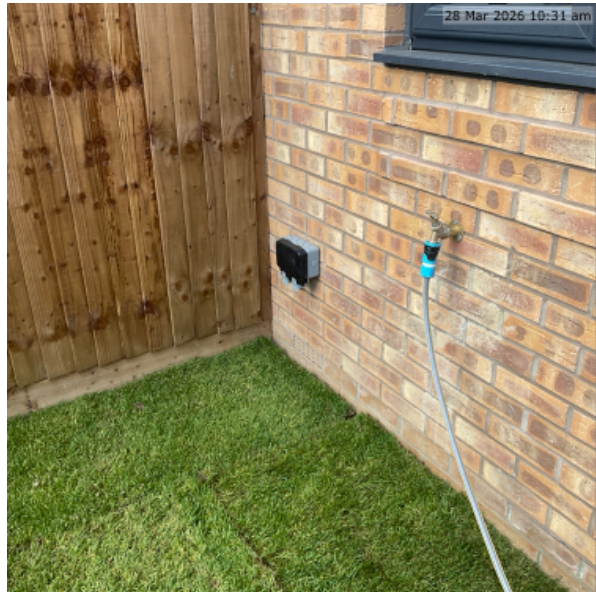
Issue 8

Description: Blocked Weep Vent

A weep vent has been obstructed with mortar/debris.

Approved Document C requires cavity drainage.

NHBC 6.1 requires weep vents to remain clear.

The blockage prevents moisture from escaping the cavity, increasing risk of damp. This does not meet expected standards.

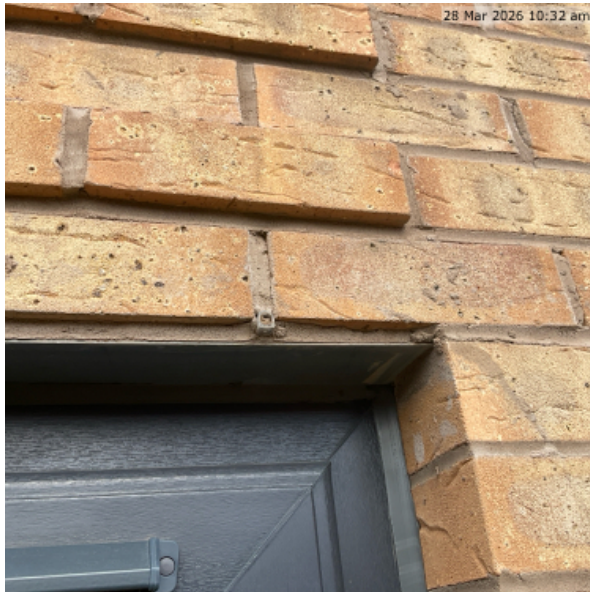
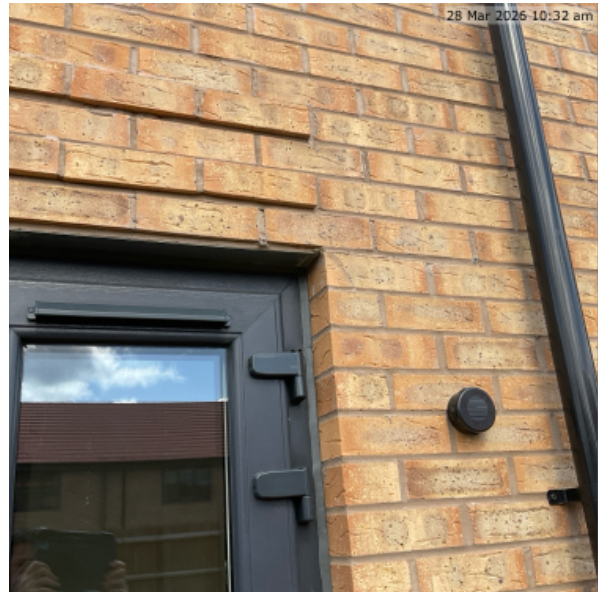
Issue 9

Description: Blocked Weep Vent

A weep vent has been obstructed with mortar/debris.

Approved Document C requires cavity drainage.

NHBC 6.1 requires weep vents to remain clear.

The blockage prevents moisture from escaping the cavity, increasing risk of damp. This does not meet expected standards.

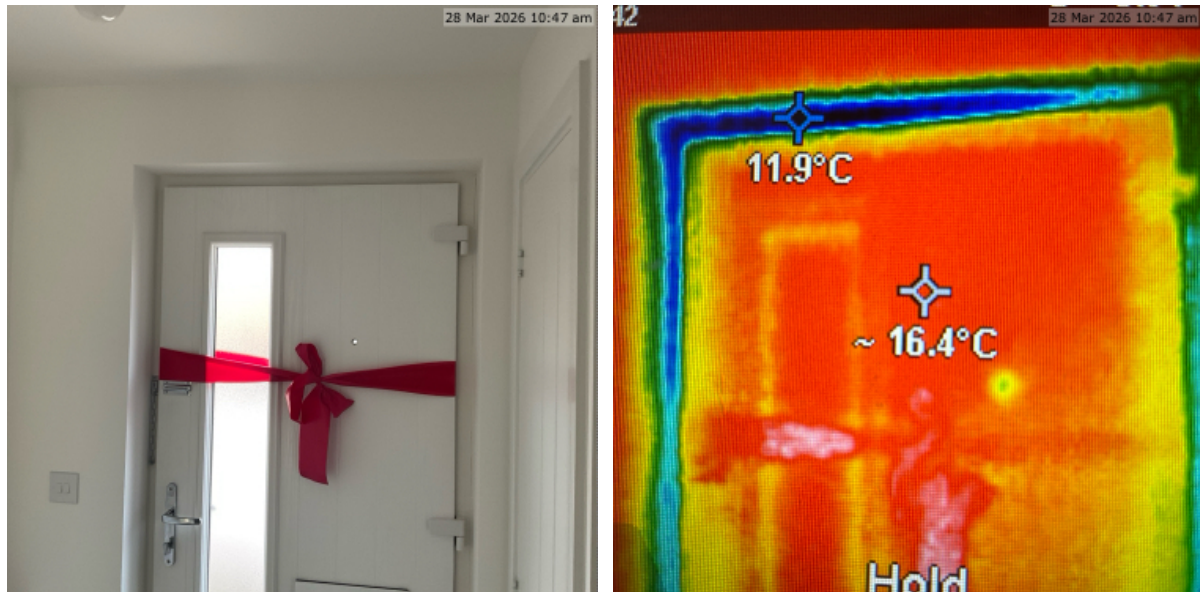
## Issue 10

Description: Front Door Dropped and Allowing Air Ingress

The front door has dropped within the frame and is no longer forming a tight seal. Cold air ingress is noticeable around the door perimeter.

Approved Document L1A requires the building envelope to limit uncontrolled air leakage.

NHBC 6.7 requires doors to be correctly aligned and sealed.

The misalignment affects both performance and usability and does not meet expected standards.

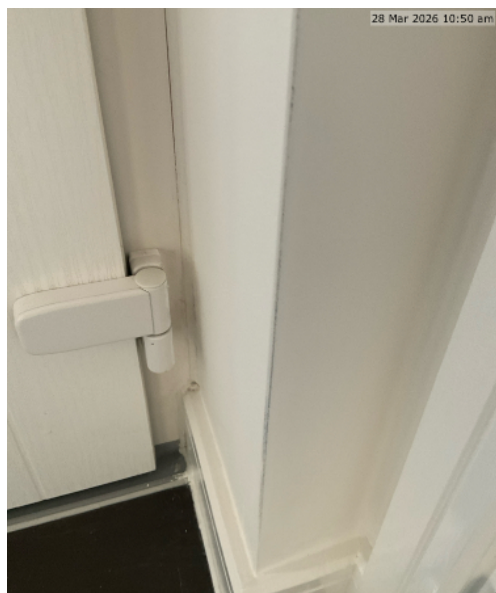
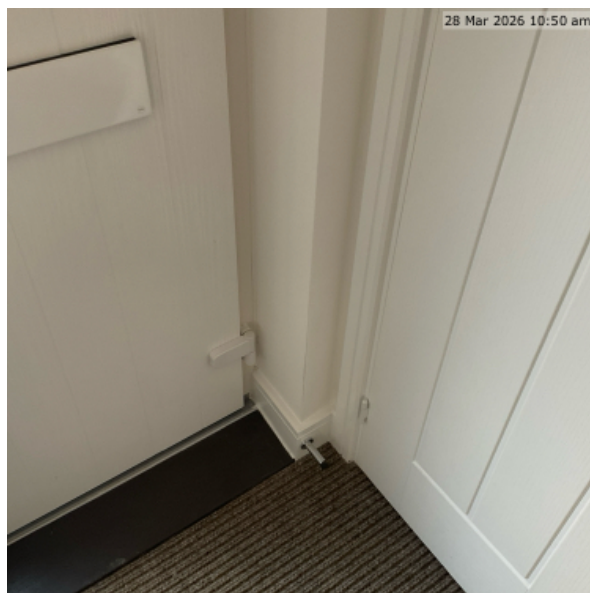
### Issue 11

Description: Poor Finish to Wall Joint

Observation  
Wall junction shows uneven decorative finish.

Relevant Guidelines  
NHBC 9.1

Assessment  
Detracts from finish; poor workmanship.

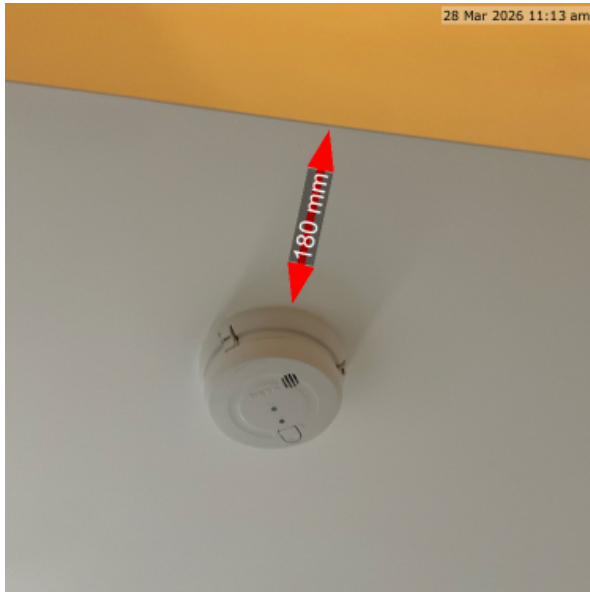
## Issue 12

Description: Smoke Detector Installed Too Close to Stair Opening

The smoke detector has been installed approximately 180mm from the edge of the stair opening on the landing. This places the detector within close proximity to the stairwell void and within the exclusion zone for detector positioning.

Approved Document B (Fire Safety) requires smoke alarms to be installed in accordance with BS 5839-6 to provide effective early warning.

BS 5839-6 recommends that smoke detectors should be positioned at least 300mm from walls, edges and obstructions, including stair openings, to ensure accurate detection performance.

The detector is positioned closer than the recommended 300mm minimum distance, which may result in airflow from the stairwell affecting its operation. This could delay smoke reaching the sensor and reduce the effectiveness of early detection.

The current installation does not align with recommended siting guidance and does not reflect the expected standard for fire detection systems within a newly constructed dwelling.

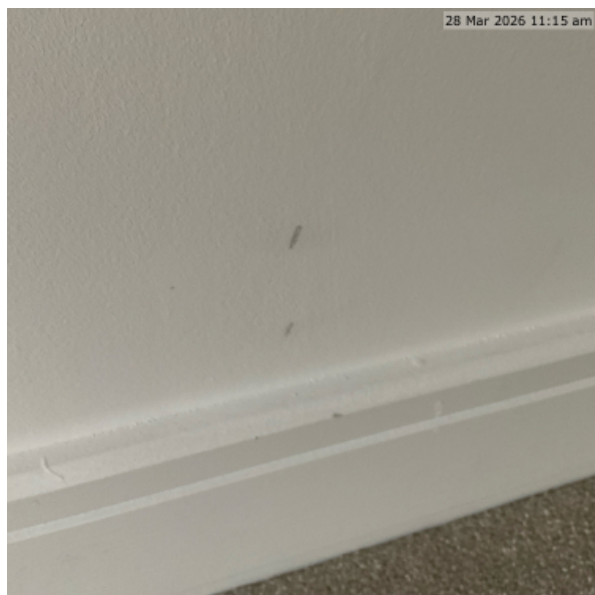
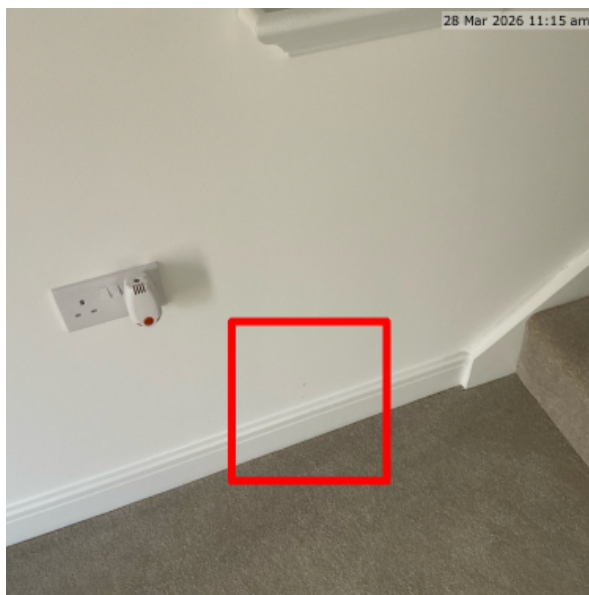
### Issue 13

Description: Wall Blemish

Observation  
Visible blemish to wall surface.

Relevant Guidelines  
NHBC 9.1

Assessment  
Minor but visible defect.

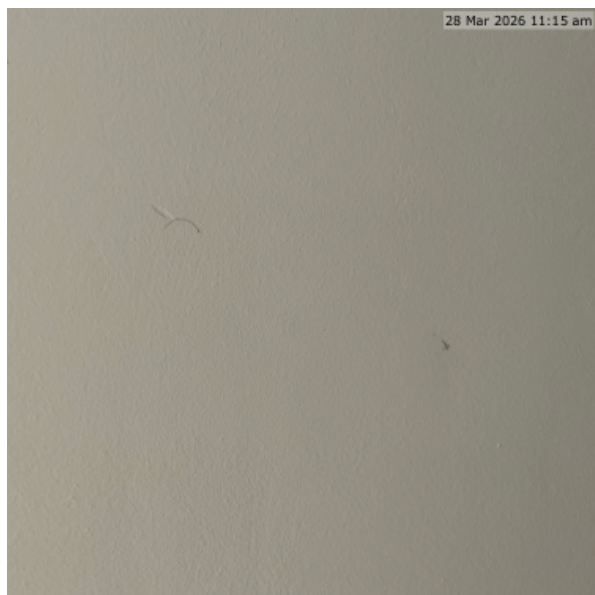
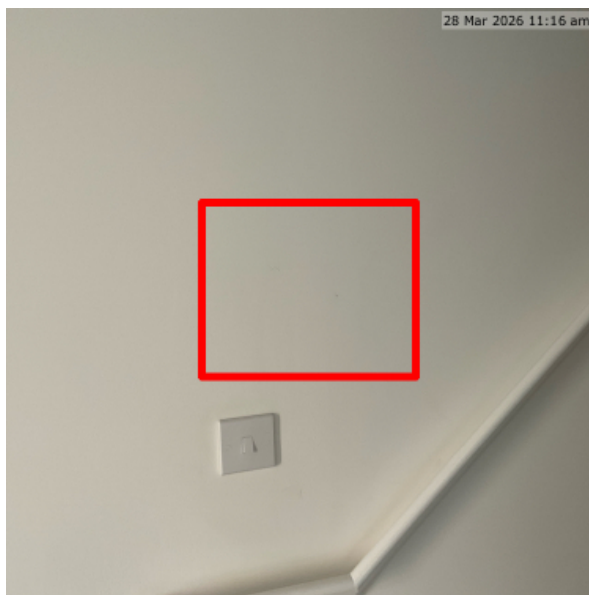
### Issue 14

Description: Wall Dent and Blemish

Observation  
Dent and surface marking visible.

Relevant Guidelines  
NHBC 9.1

Assessment  
Detracts from finish.

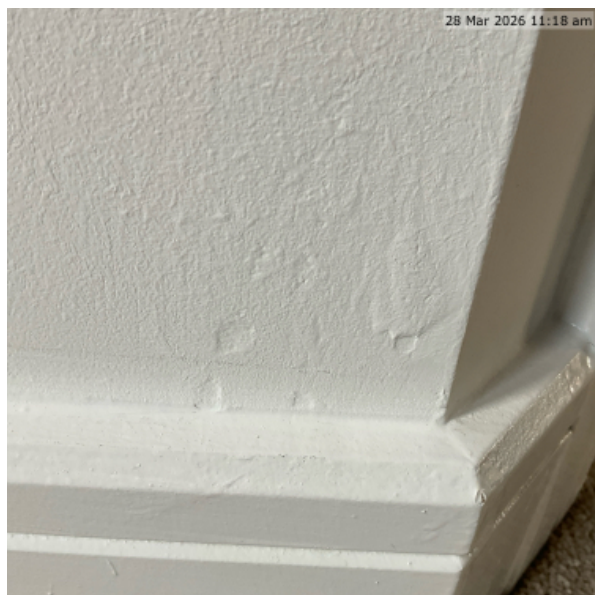
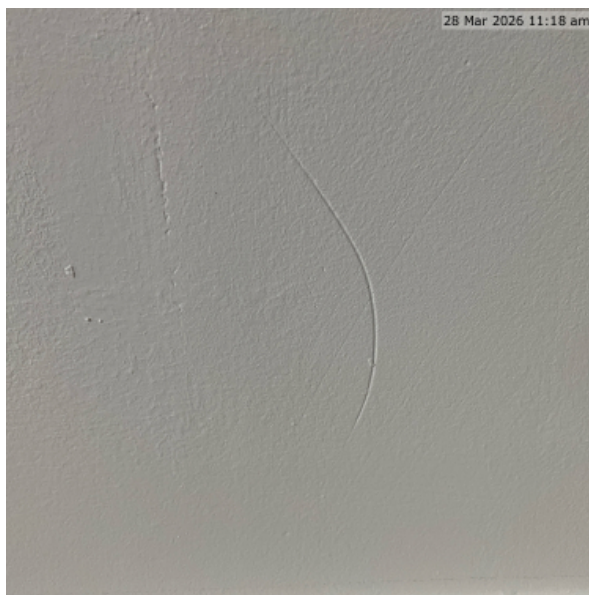
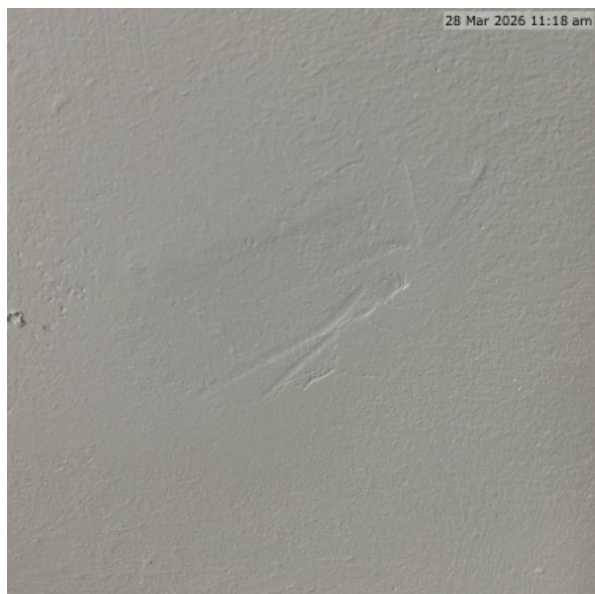
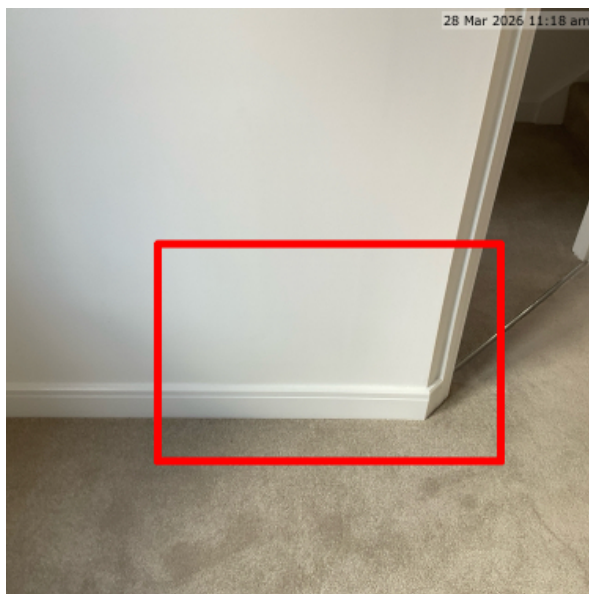
Issue 15

Description: Poor Plaster Finish (Multiple Areas)

Observation  
Dents and scratches visible across plaster surfaces.

Relevant Guidelines  
NHBC 9.1

Assessment  
Below expected finish quality.

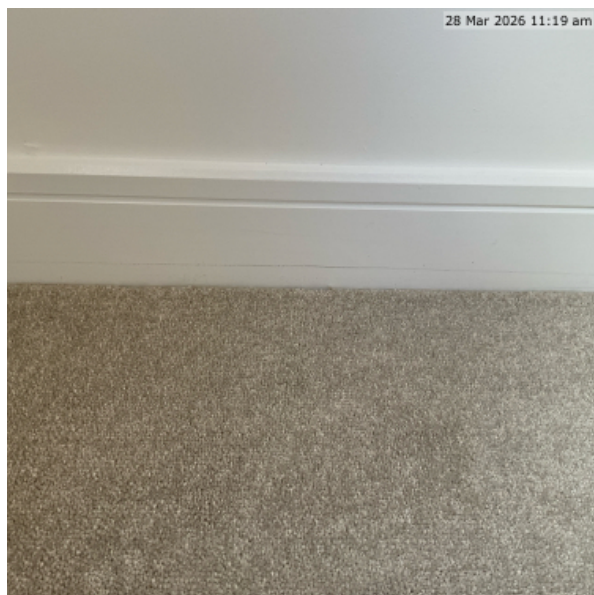
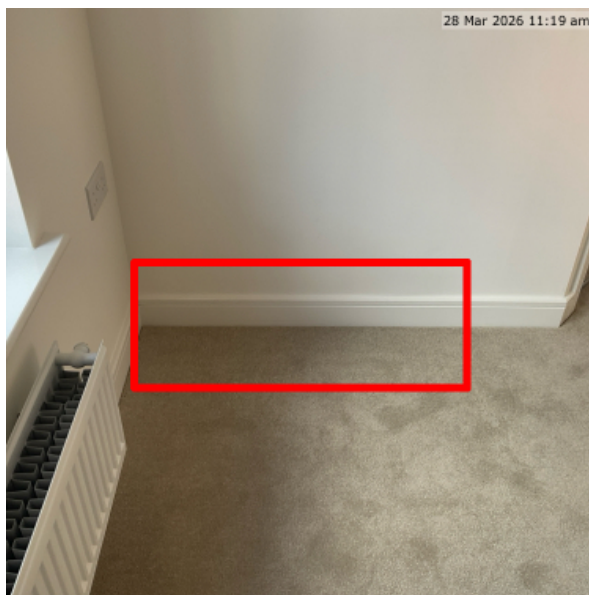
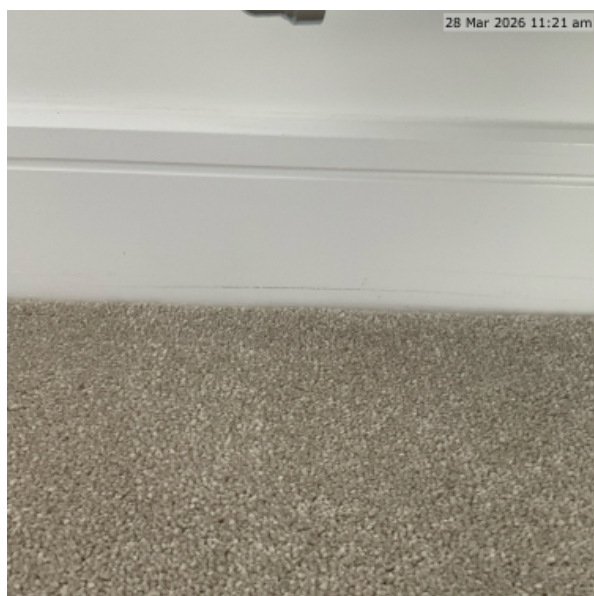
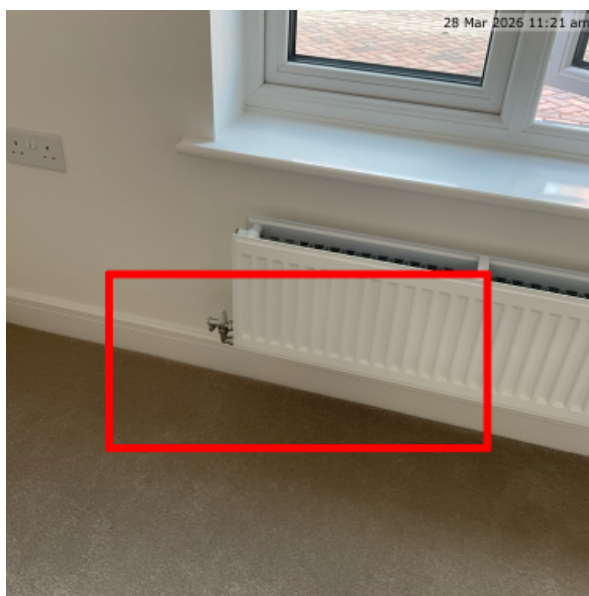
### Issue 16

Description: Skirting Board Blemishes

Observation  
Stubborn marks visible to skirting.

Relevant Guidelines  
NHBC 9.1

Assessment  
Poor finishing/cleaning.

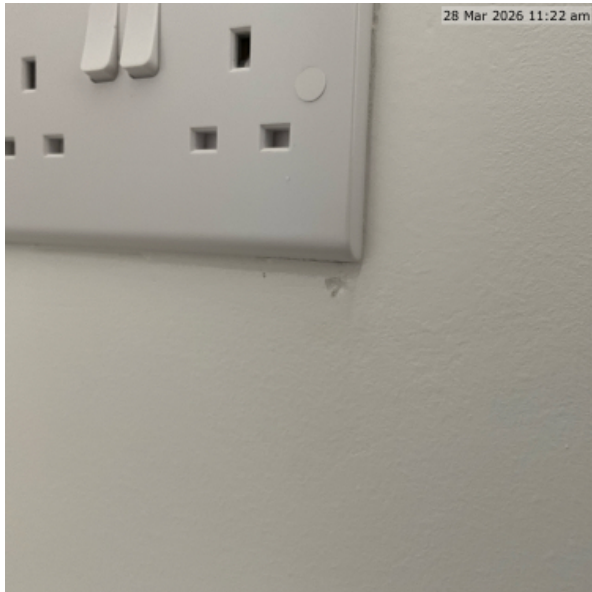
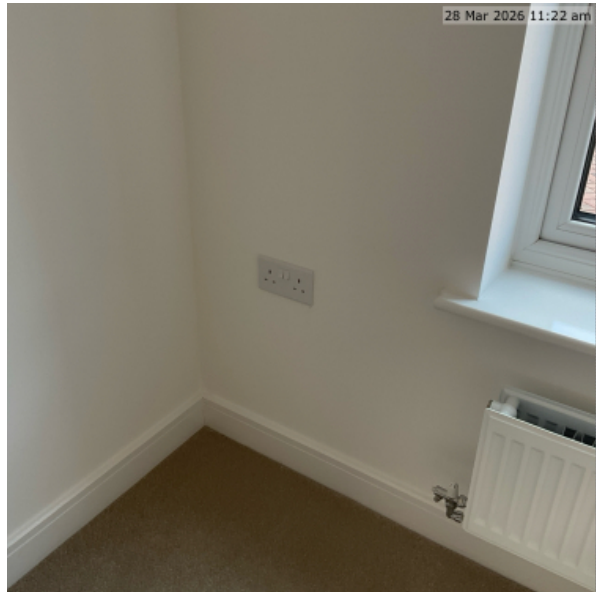
Issue 17

Description: Dent Under Faceplate

Observation  
Dent to wall beneath faceplate.

Relevant Guidelines  
NHBC 9.1

Assessment  
Visible defect from installation damage.

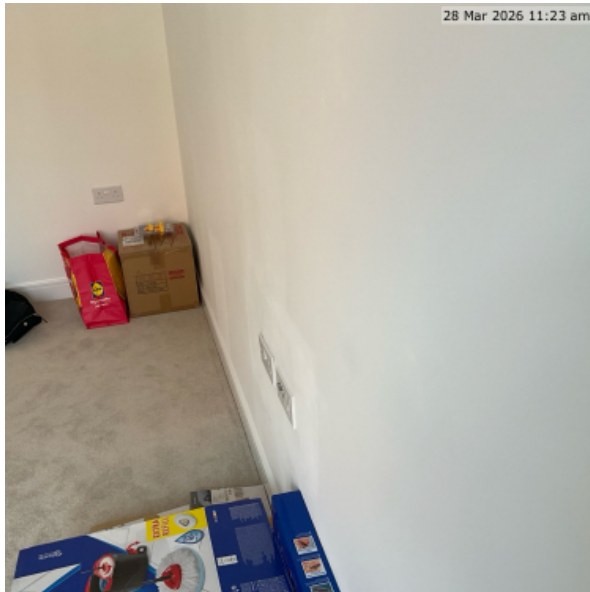
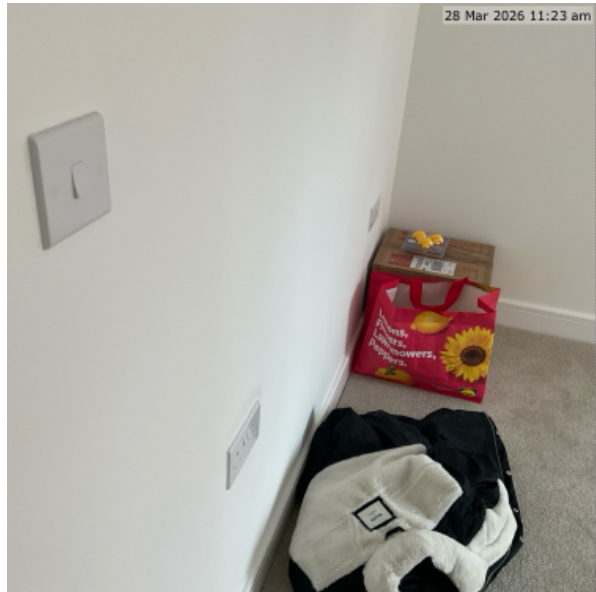
Issue 18

Description: Extremely Patchy Wall Finish

Observation  
Significant inconsistency in paint finish.

Relevant Guidelines  
NHBC 9.1

Assessment  
Does not provide uniform finish expected.

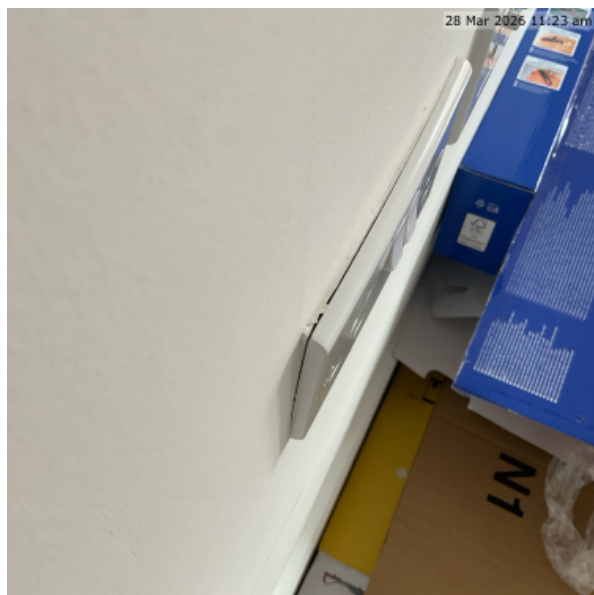
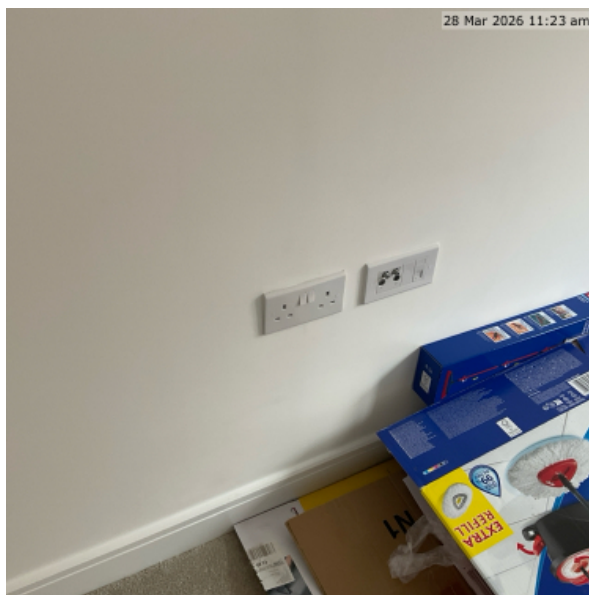
### Issue 19

Description: Loose Socket Faceplate

Observation  
Faceplate loose with gap behind.

Relevant Guidelines  
Approved Document P, NHBC 8.1

Assessment  
Poor fixing; requires securing.

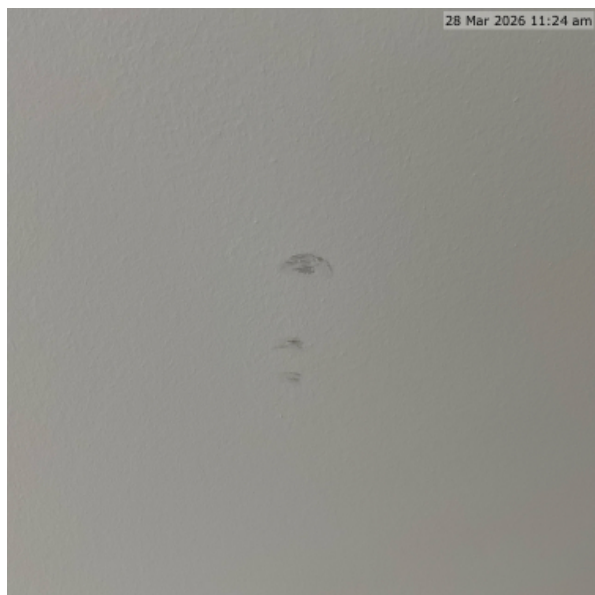
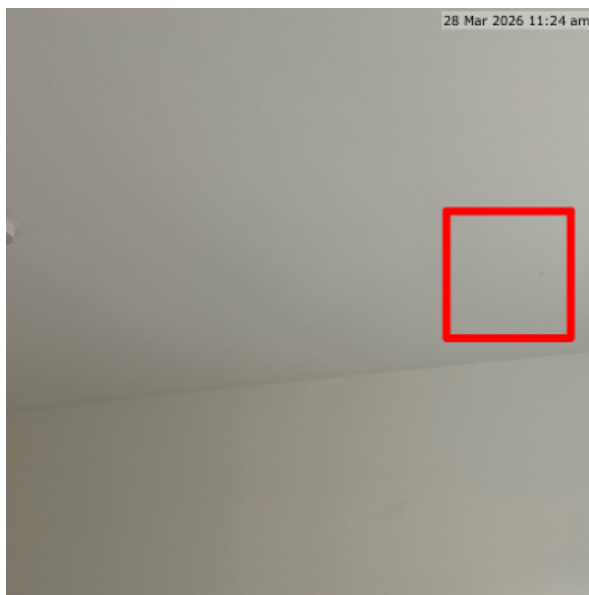
### Issue 20

Description: Ceiling Finish Damage

Observation  
Damage to ceiling decorative finish.

Relevant Guidelines  
NHBC 9.1

Assessment  
Visible defect.

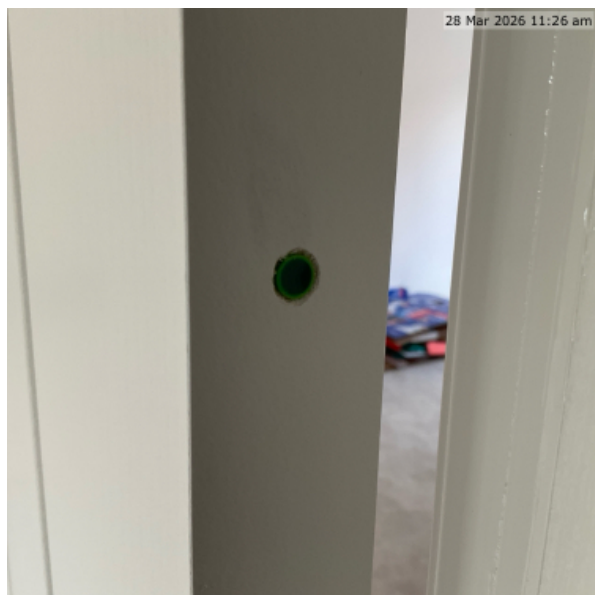
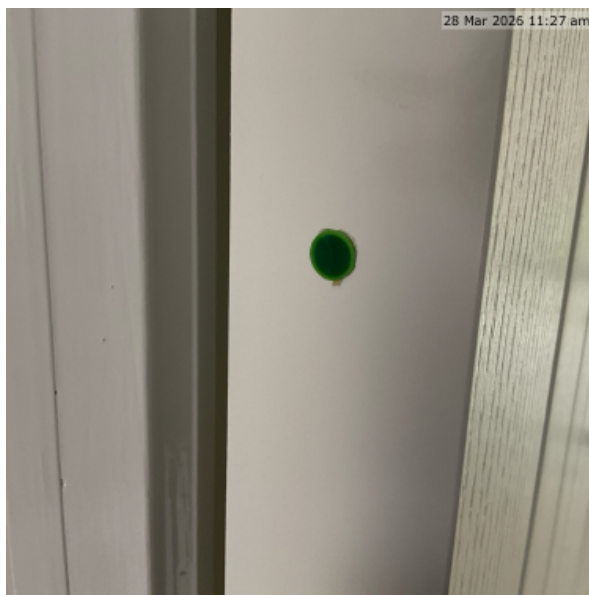
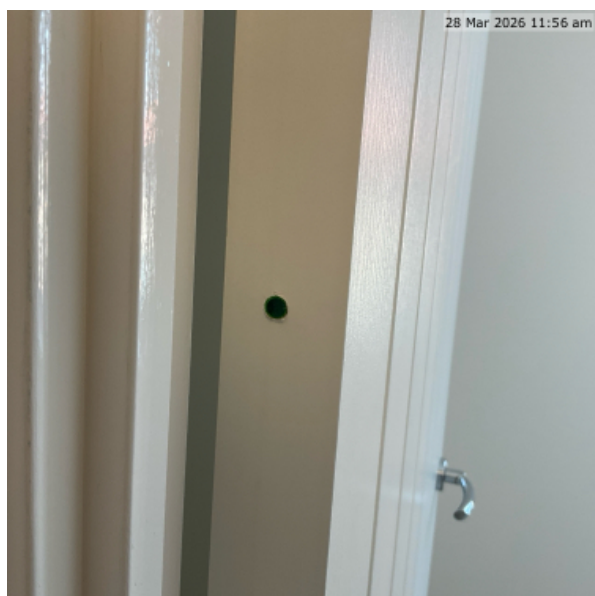
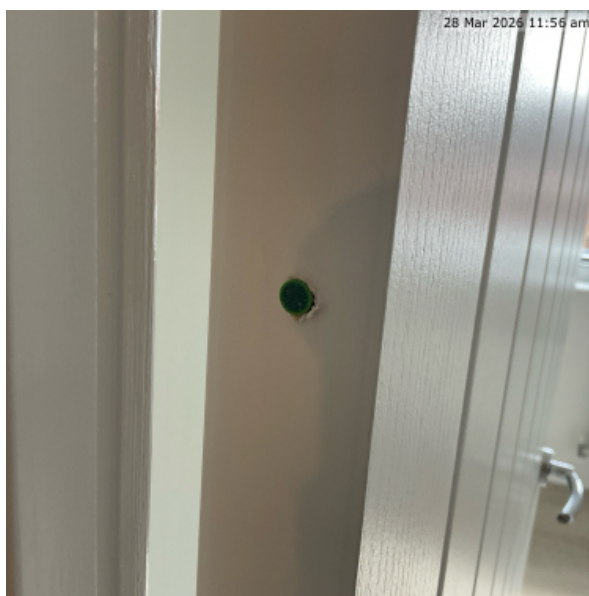
Issue 21

Description: Visible Plastic Cover Caps to Door Edges Throughout Property

Multiple internal doors throughout the property have been fitted with visible plastic cover caps to the door edges. These caps are installed within pre-drilled holes and remain exposed, contrasting with the surrounding door finish. The caps are noticeable at normal viewing height and detract from the appearance of the door leaf.

Approved Document A (Structure) requires building elements and fittings to be completed to an appropriate standard of workmanship.

NHBC Standards Chapter 9.1 (A consistent approach to finishes) states that internal joinery should present a neat and consistent appearance and be free from visible defects or poor finishing details.

Whilst these caps may be associated with manufacturer preparation for alternative hardware configurations, their visibility within a finished property detracts from the overall appearance of the joinery. In higher quality finishes, such features would typically be concealed, flush-finished or colour-matched to minimise visual impact.

The repeated presence of these exposed caps across multiple doors indicates a lack of finishing consideration and does not reflect the expected standard of internal joinery presentation within a newly constructed dwelling.

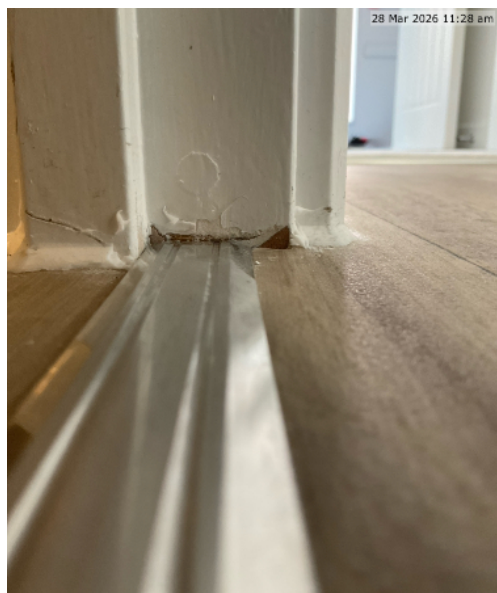
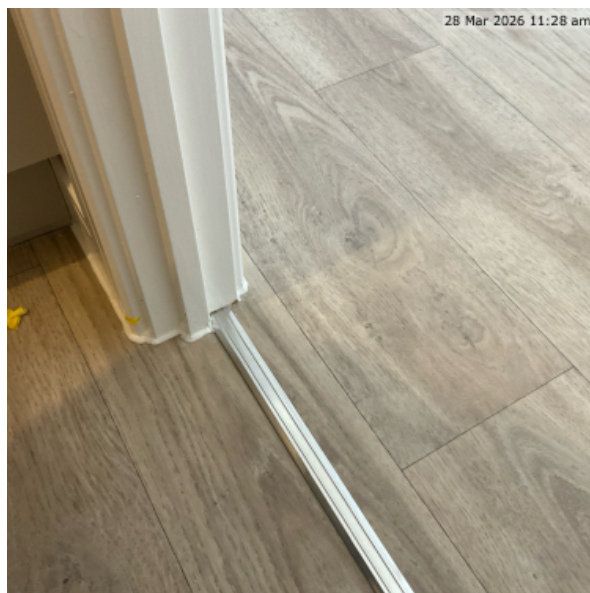
### Issue 22

Description: Damage to Door Frame Bottom

Observation  
Damage to base of frame.

Relevant Guidelines  
NHBC 9.1

Assessment  
Poor joinery finish.

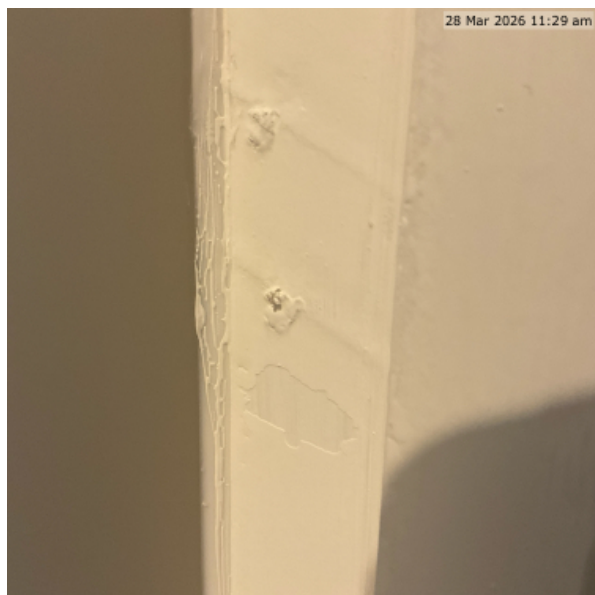
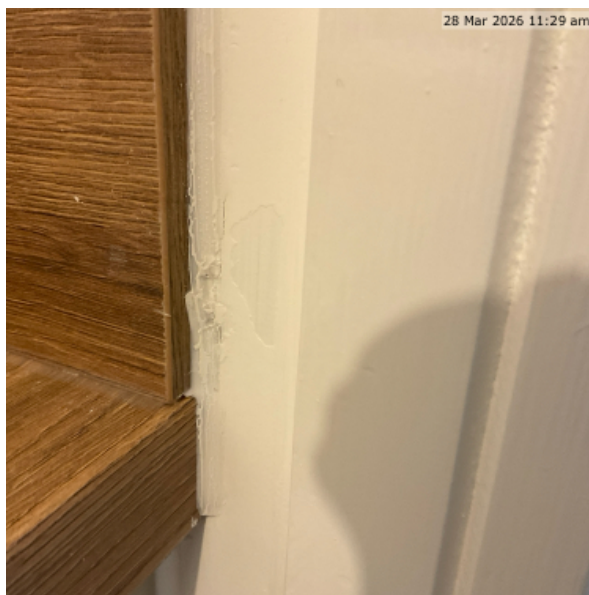
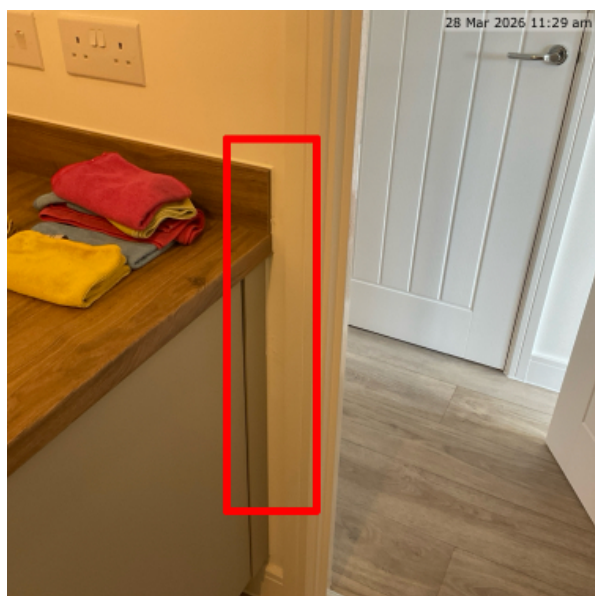
### Issue 23

Description: Poor Wall Finish (Dents and Uneven Areas)

Observation  
Multiple dents and uneven surfaces.

Relevant Guidelines  
NHBC 9.1

Assessment  
Below expected standard.

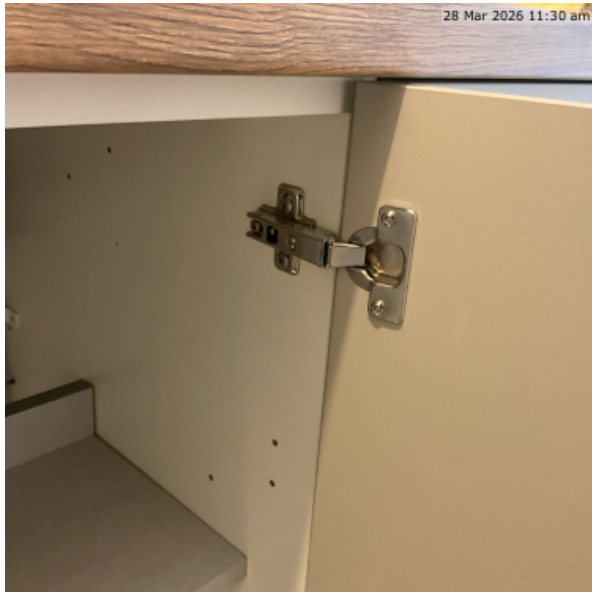
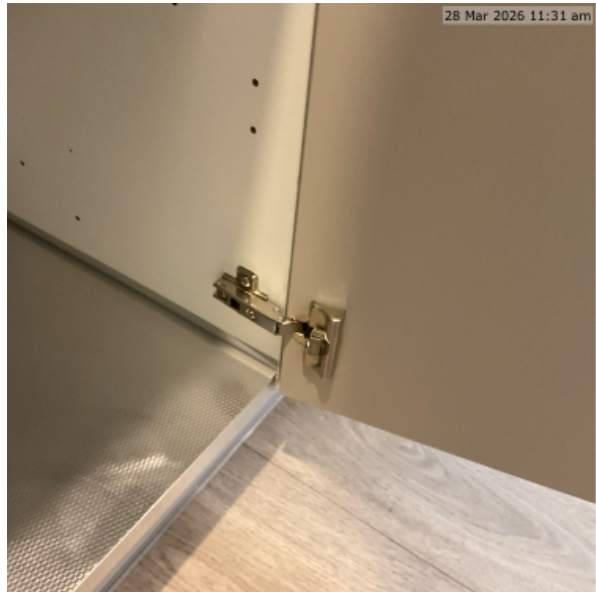
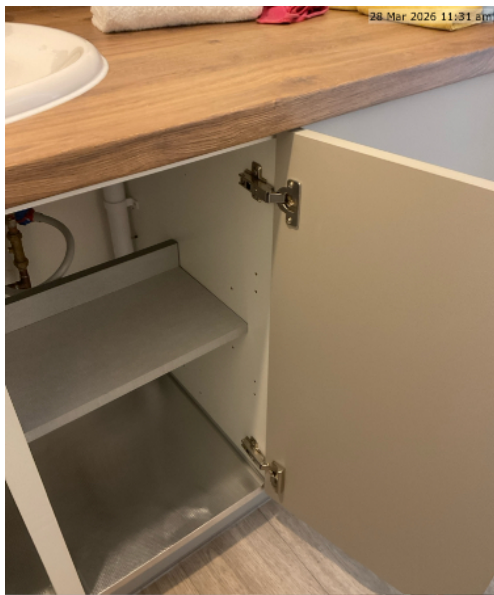
### Issue 24

Description: Hinge cap missing

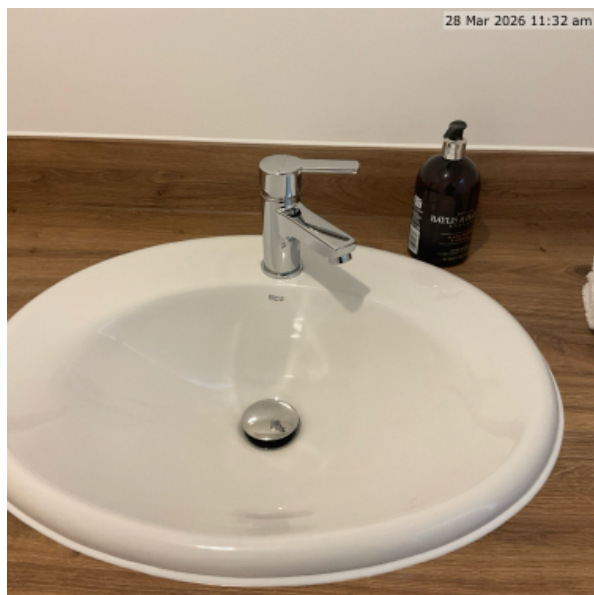
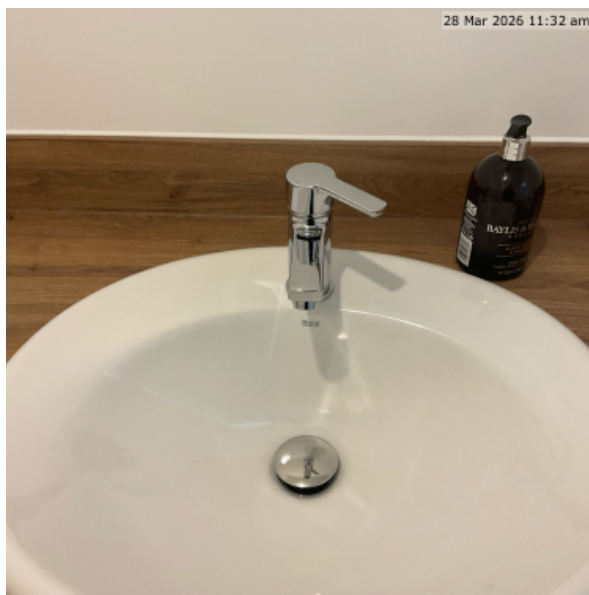
### Issue 25

Description: Movement in Mixer Tap

Observation  
Tap moves under normal use.

Relevant Guidelines  
Approved Document G, NHBC 8.1

Assessment  
Not securely fixed; requires adjustment.

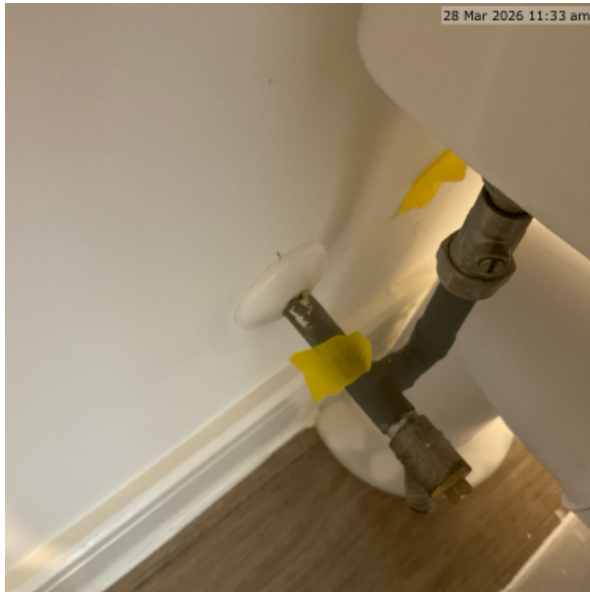
## Issue 26

Description: Poor Decorative Finish to Pipework (Previously Snagged)

Pipework within the property has been observed to have a poor decorative finish, including inconsistent paint application and visible surface imperfections. This issue was reportedly identified during a previous developer snagging inspection but remains unresolved.

Approved Document A (Structure) requires building elements to be finished to an appropriate standard of workmanship.

NHBC Standards Chapter 9.1 (A consistent approach to finishes) states that decorative finishes should be complete, uniform and free from visible defects.

The unfinished and inconsistent decorative finish detracts from the appearance of the pipework and indicates that snagging works have not been properly completed. The fact this item was previously identified but not rectified highlights a lack of adequate quality control prior to handover. Internal finishes should be complete and free from visible defects at completion, and this does not reflect the expected standard.

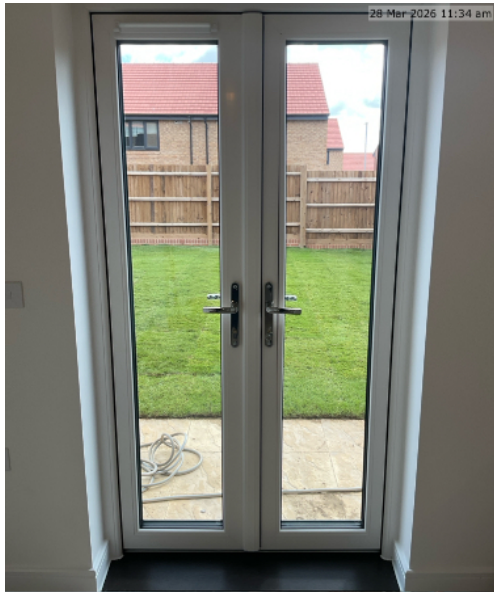
## Issue 27

Description: Patio Doors Difficult to Lock

The patio doors have been observed to be difficult to lock during normal operation. Increased force is required to engage the locking mechanism, suggesting resistance within the system.

Approved Document L1A (Conservation of fuel and power) requires doors to form part of the building envelope and operate correctly.

NHBC Standards Chapter 6.7 (Doors, windows and glazing) requires doors to be correctly aligned and operate smoothly.

The difficulty in locking indicates that the doors may have dropped out of alignment or have not been properly adjusted. This affects both usability and performance and does not reflect the expected standard of installation.
