3 Bedroom House

# Snagging Details

Description: Snagging Survey

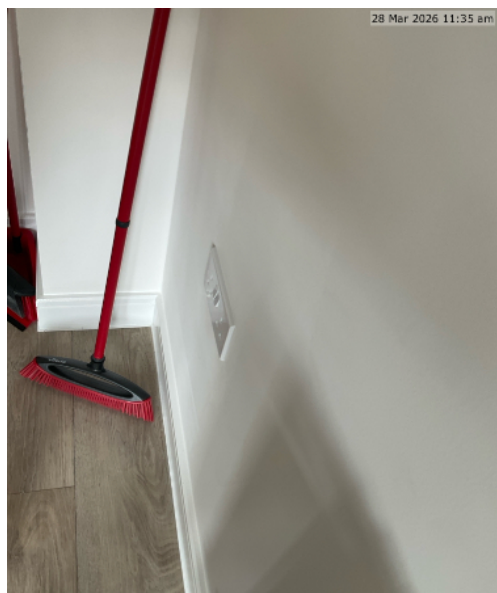
## Issue 28

Description: Patchy Decorative Finish to Wall

The wall surface has been observed to contain a patchy decorative finish with inconsistent paint coverage.

NHBC 9.1 requires decorative finishes to be uniform.

The inconsistency detracts from appearance and indicates inadequate preparation or application.

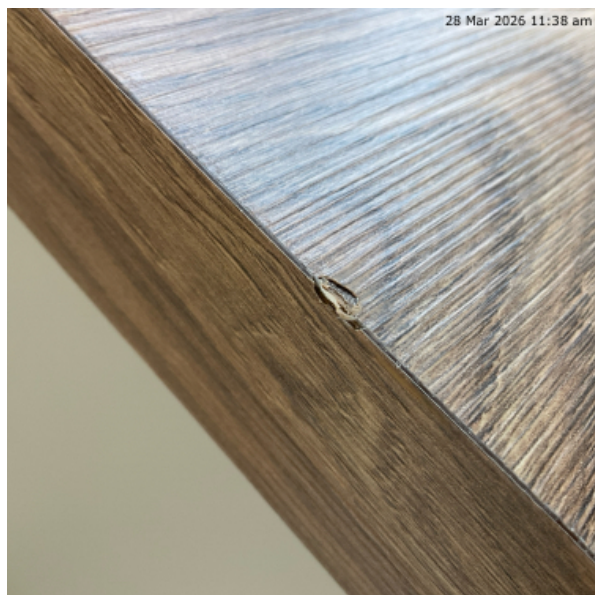
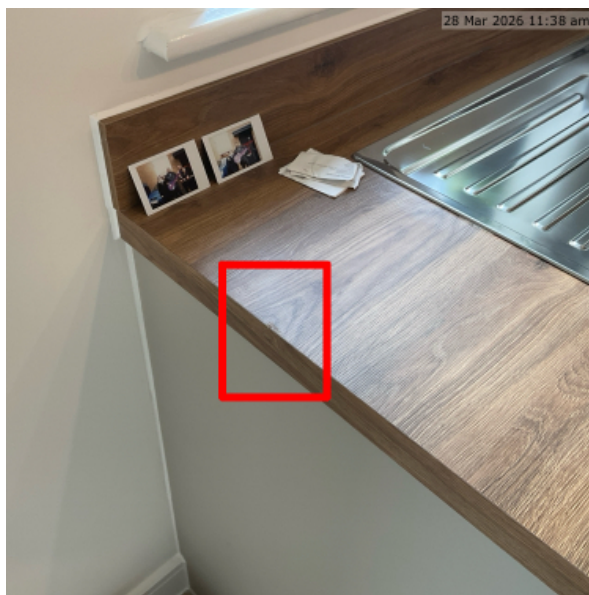
### Issue 29

Description: Chipped Worktop

A section of the worktop has been observed to be chipped, exposing the underlying material.

NHBC 9.1 requires fittings to be free from visible damage.

The damage detracts from appearance and may affect durability.
